# **Black Watch Pass Rock Cut Stabilization**

Bermuda

## **Annex D Drawings and Reference Documents**

Project No. 41-71-76

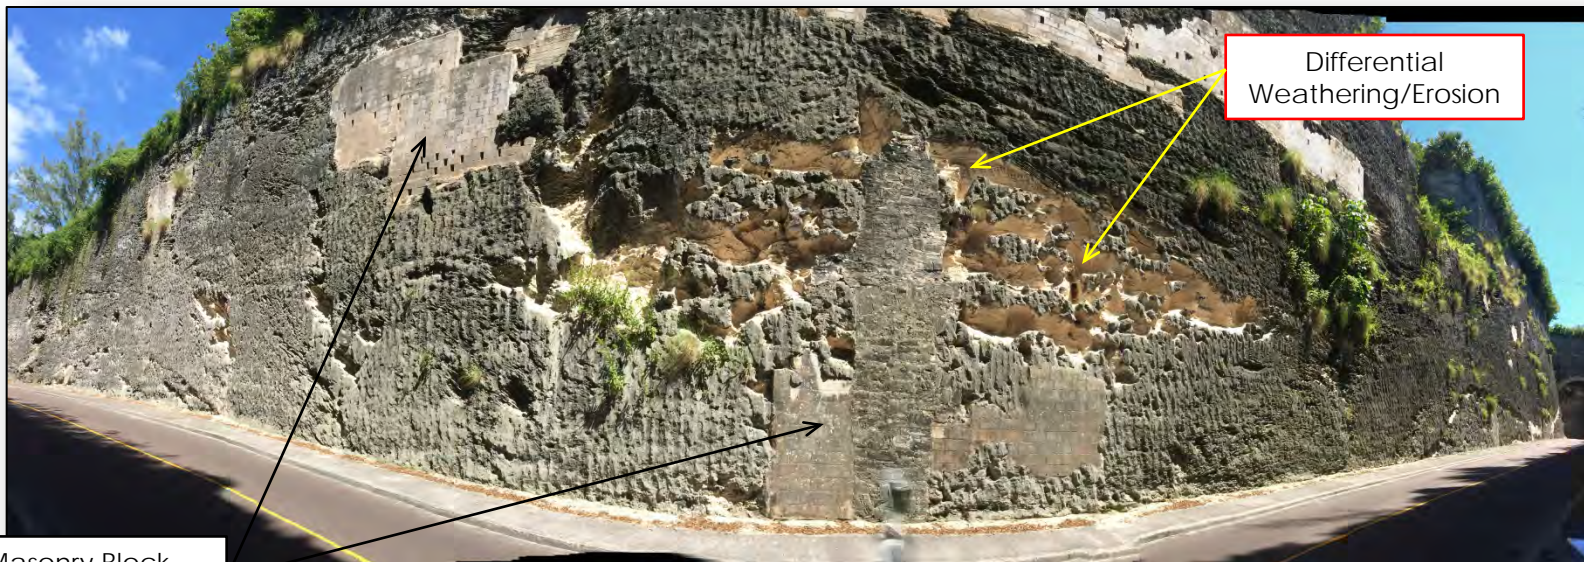
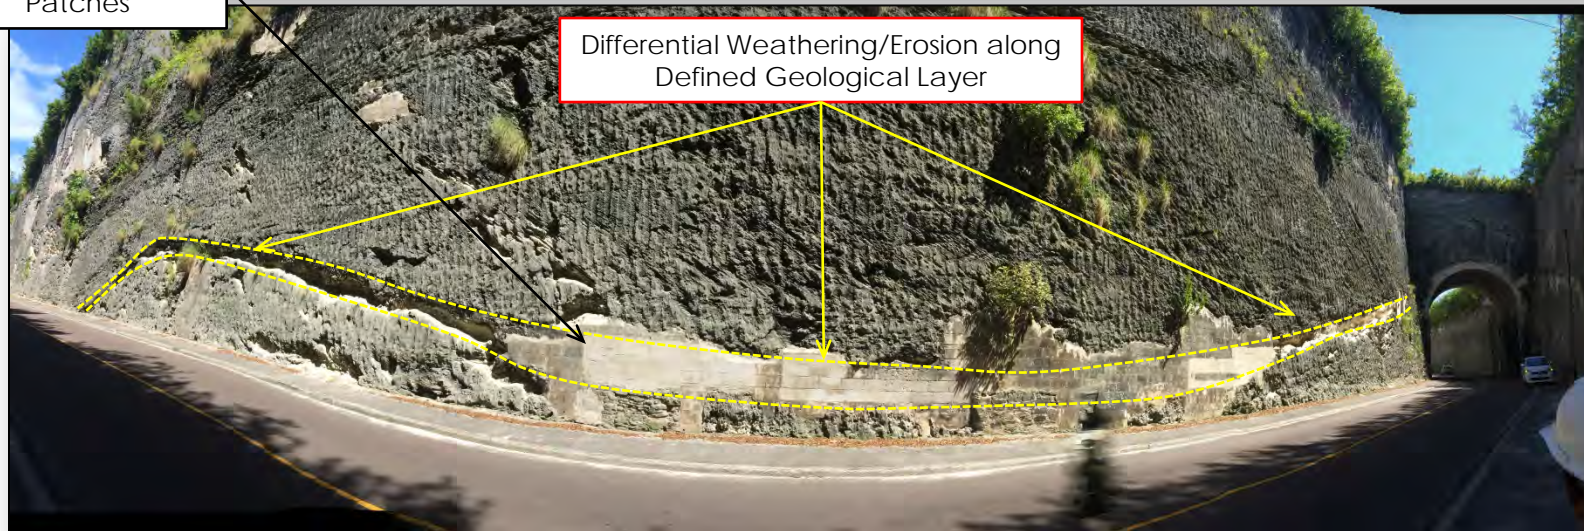
FIGURE 1  
PHOTOS SHOWING DIFFERENTIAL EROSION

Masonry Block Patches

Differential Weathering/Erosion

Differential Weathering/Erosion along Defined Geological Layer

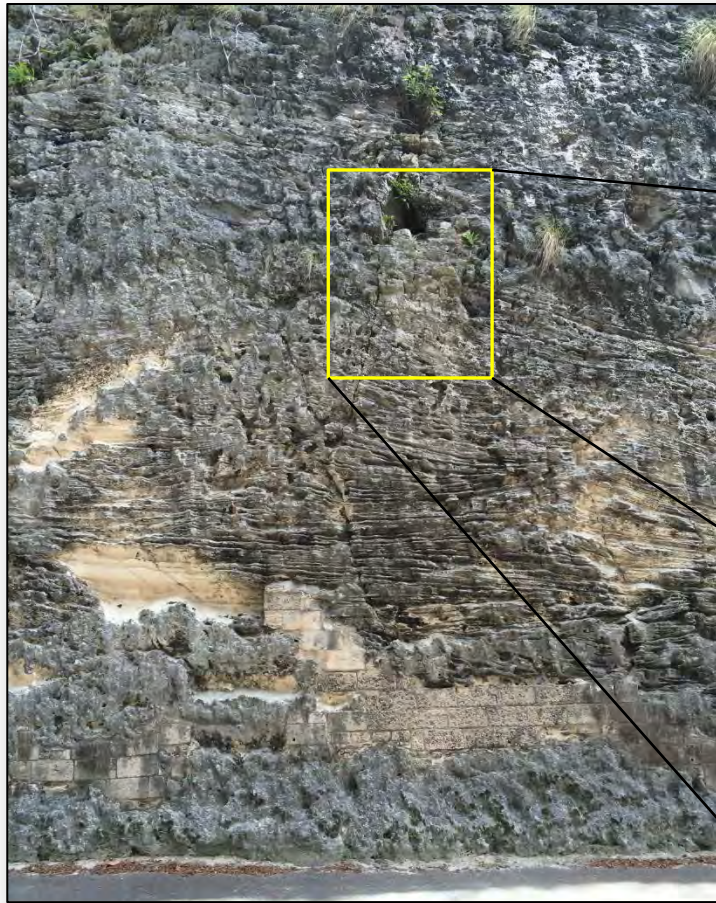
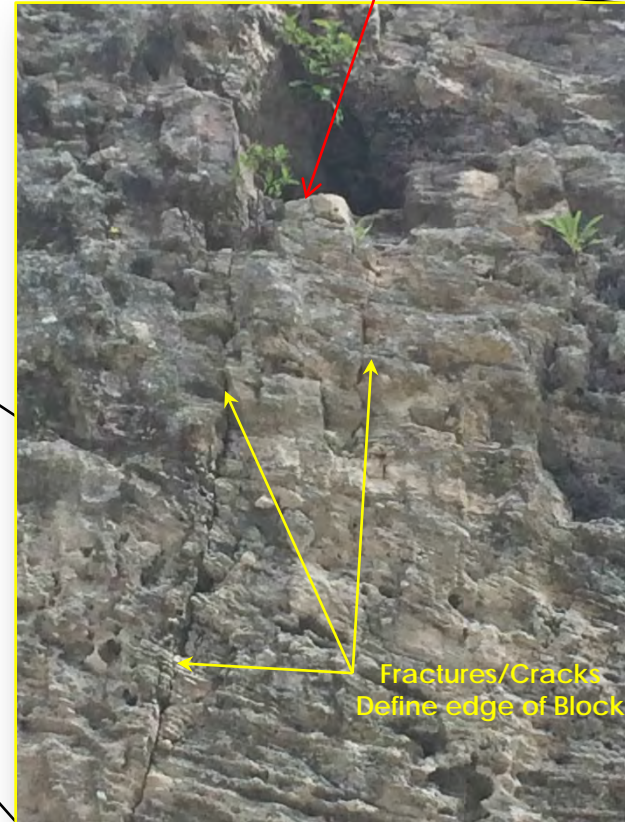
**FIGURE 4**  
PHOTO SHOWING FRACTURES OR CRACKS IN ROCK FACE GIVING RISE TO  
POTENTIALLY UNSTABLE ROCK MASS/BLOCK

Potential Localized  
Rockfall Failure

Fractures/Cracks  
Define edge of Block

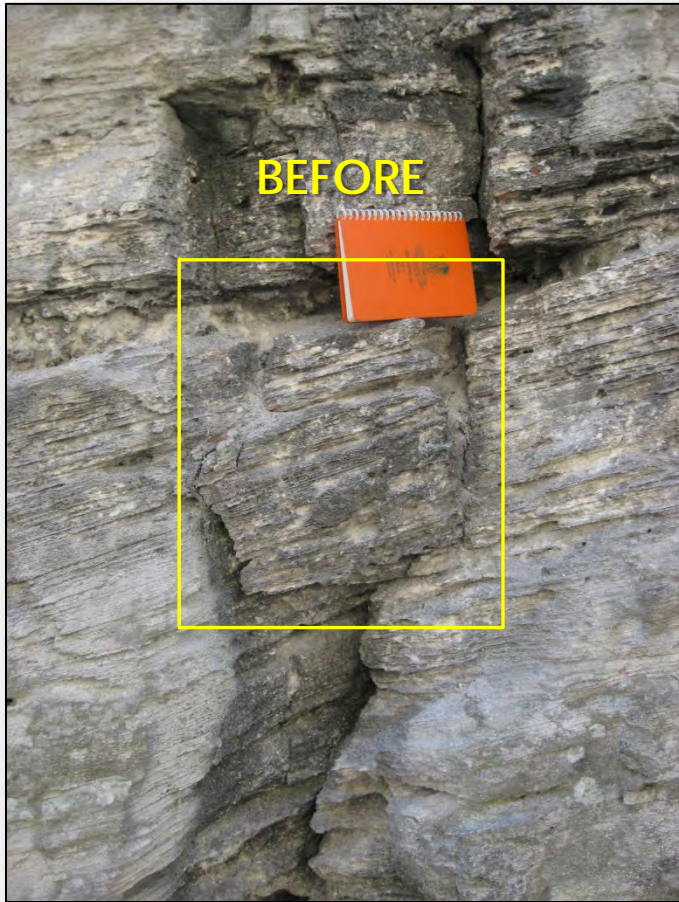
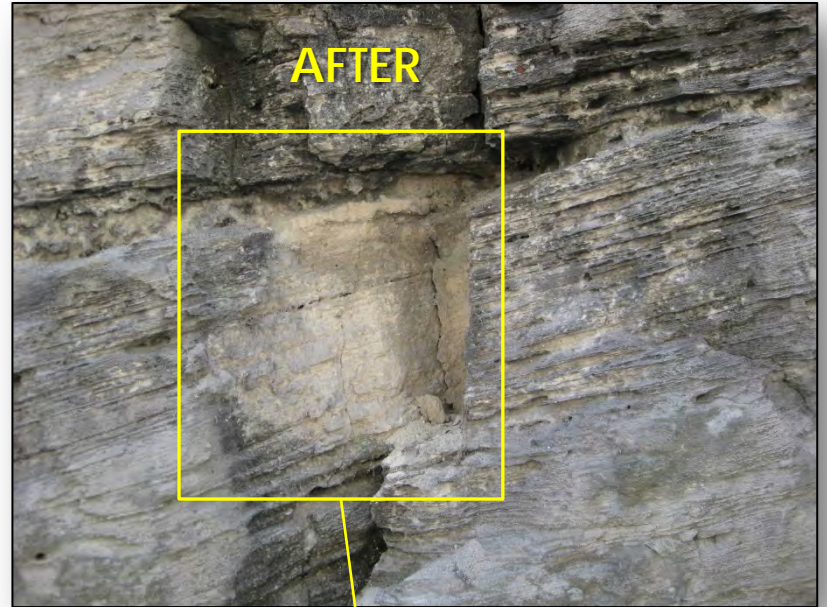
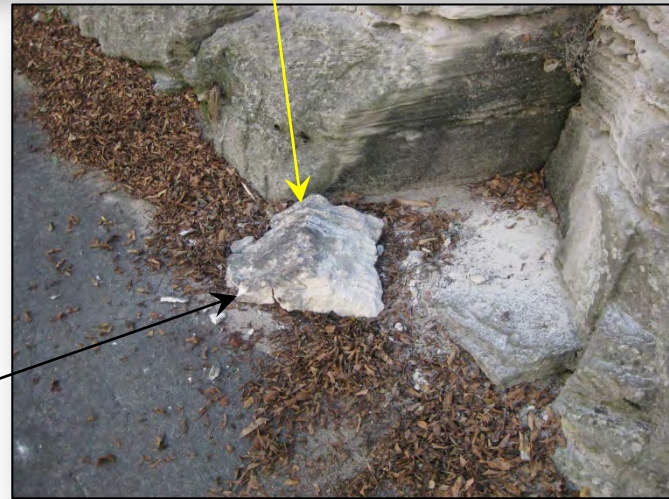
FIGURE 5  
PHOTO SHOWING ROCK BLOCK THAT WAS REMOVED WITH HAND

Loose Block on Ground
